# A REVEGETATION STUDY and GUIDE

## For the Flathead River Basin

**May, 2010**

**Prepared By:** Watershed Consulting, LLC  
PO Box 17287  
Missoula, Montana 59808

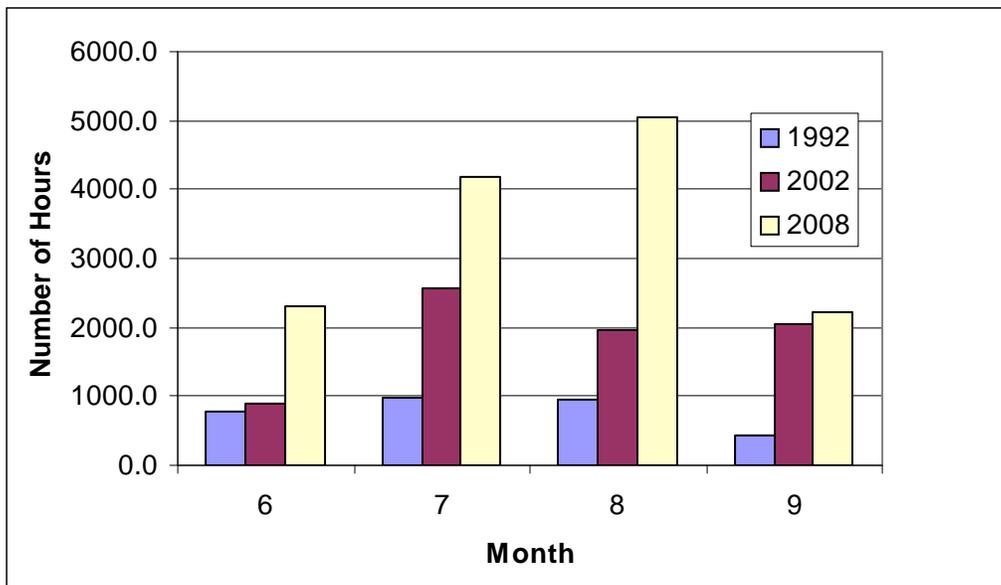
**Figure 3.** The estimated total number of boating hours per month on the lower reach of the Flathead River and sloughs.

Boating use in 2008, consequently, increased in both the river and sloughs by two to three times since 2002 and four to five times since levels in 1992 (Deley and Cavigli, 2008), as shown in Figure 3. As boat usage increases, so have issues related to their use, including noise pollution and, of interest to this report, the eroding power of boat wakes on stream banks. A detailed discussion of the erosive forces from boat wakes can be found in [Appendix D](#).

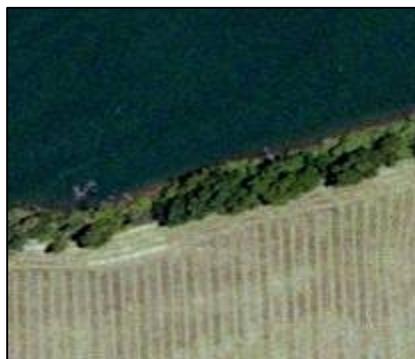
**Figure 4.** Streambank with thin strip of mature vegetation.

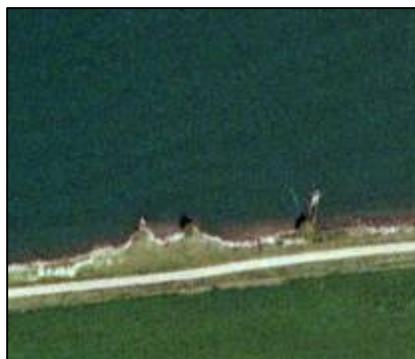
**Figure 5.** Streambank with no vegetation and road.

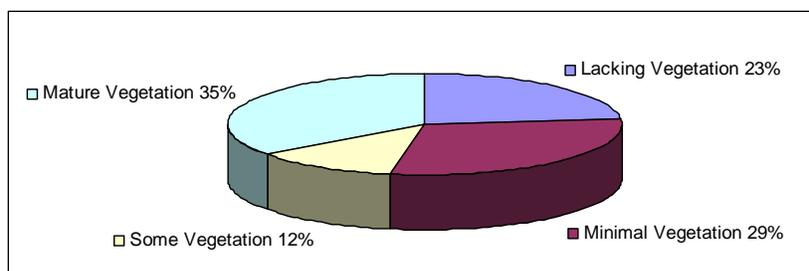
**Figure 6.** Riparian vegetation types and frequency

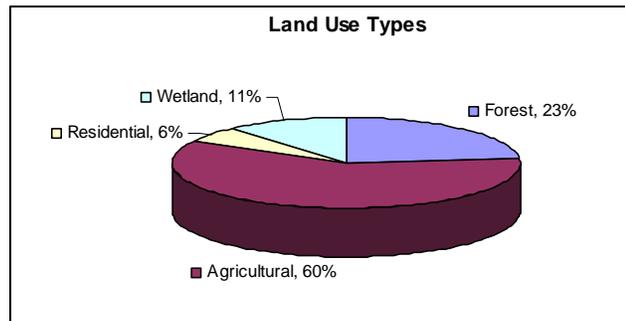
**Figure 11.** Land use types and frequency

Residential land use was primarily located near Flathead Lake and occupies 6% of stream banks. Figure 11 shows the distribution of land use types, calculated by the length of stream bank bordered by that associated land use type.

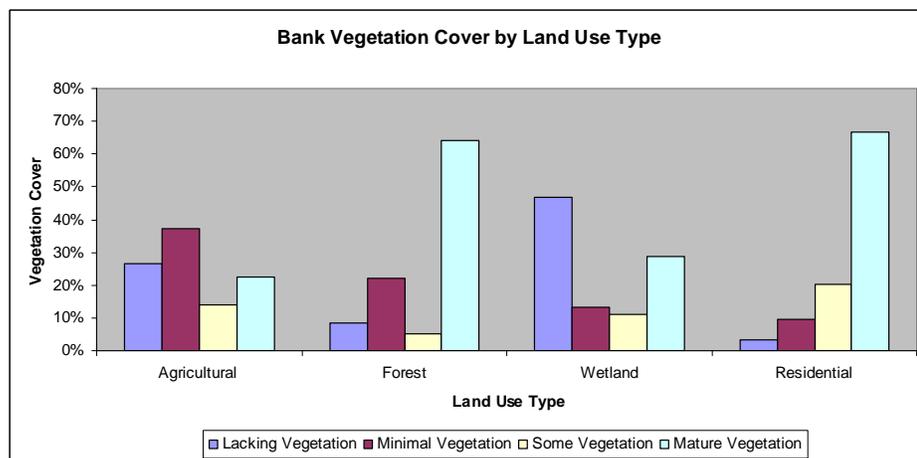
**Figure 12.** Bank vegetation by land use type

With a general understanding of the types of riparian cover and the types of land use in the study area, further analysis was done to correlate riparian cover to land uses. Not surprisingly,

forested lands had the highest percentage of mature vegetation. Residential land use types also had a high percentage of banks with mature vegetation, which reflects the values held by people who buy property in this area. Agriculture,

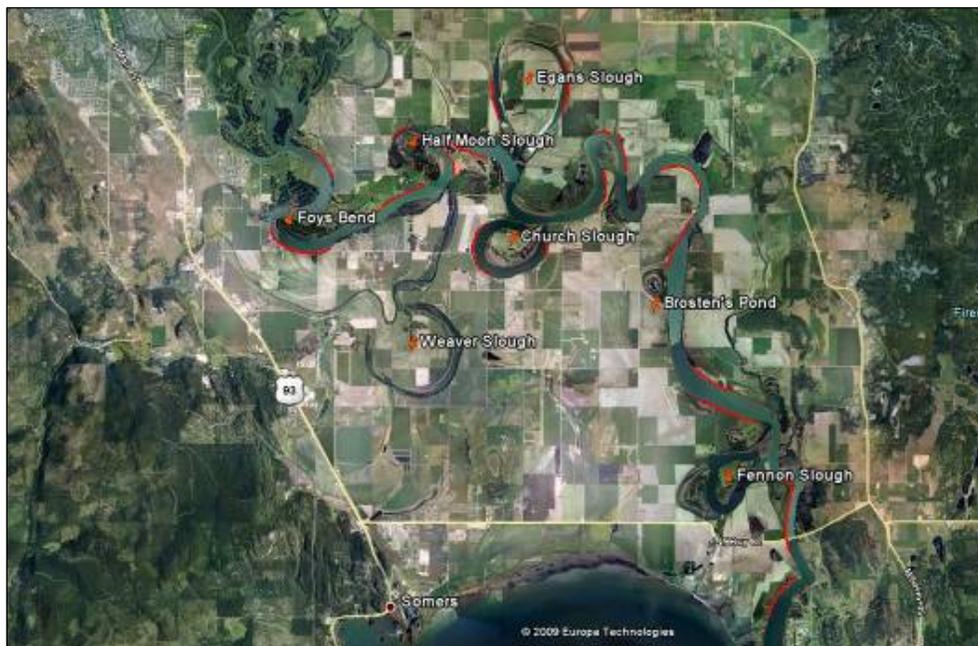
**Figure 13.** Erosional areas within study area

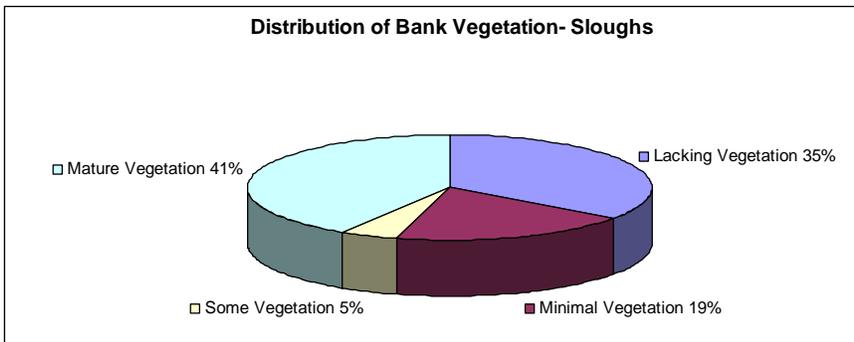
**Figure 14.** Distribution of bank vegetation in sloughs

Bank vegetation in sloughs is generally either very well established or mostly lacking (Figure 14). Though attributing causes to these statistics is beyond the scope of this report, the dichotomy between forested and non-forested lands in sloughs may be related to the conservation easements that have been targeted to these areas.

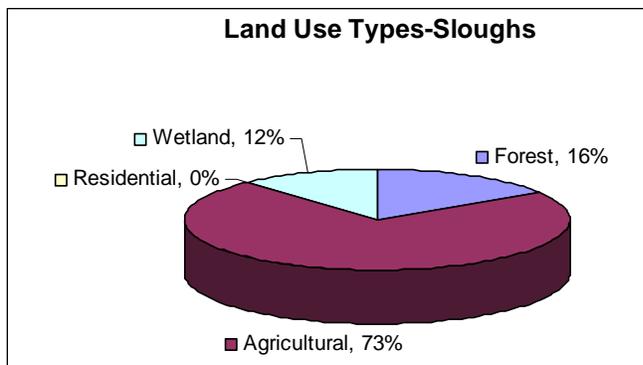
**Figure 15.** Land use type in sloughs

As with the main stem of the river, Agriculture dominates the land uses of the sloughs (Figure 15).

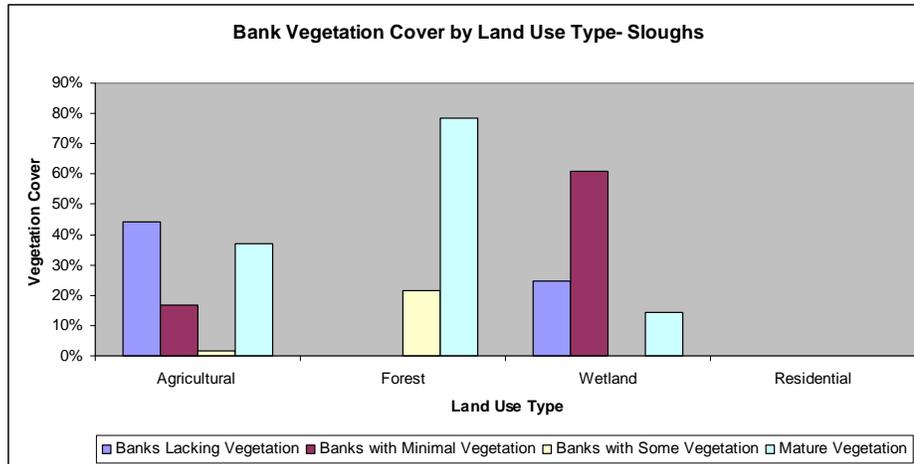
**Figure 16.** Bank vegetation by land use type in sloughs

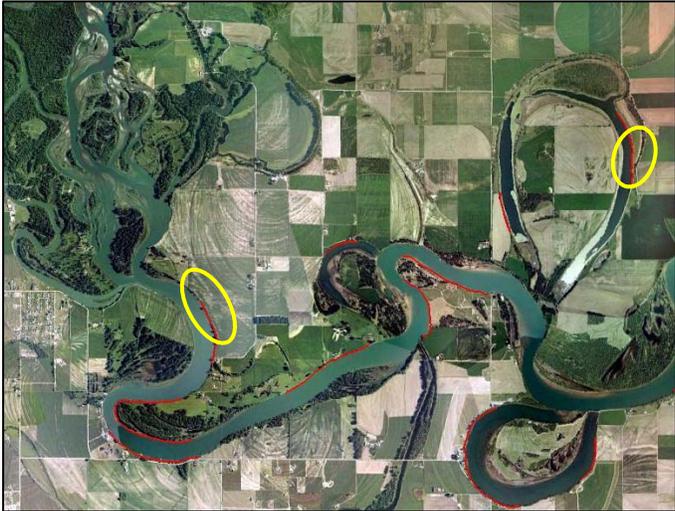
**Figure 17.** Revegetation Site Assessment Project Areas

In 2007 and 2008, Watershed Consulting implemented a streamside revegetation project in two areas of the Flathead River, along the left bank (facing downstream) of the north-westernmost section of the Study Area and in the south-easternmost section of Egan’s Slough. We returned to monitor plant establishment in each of the three subsequent years in an attempt to explore a few of the factors that influence revegetation success specific to the Flathead River ecosystem. Figure 17 shows the locations of the projects (in yellow).

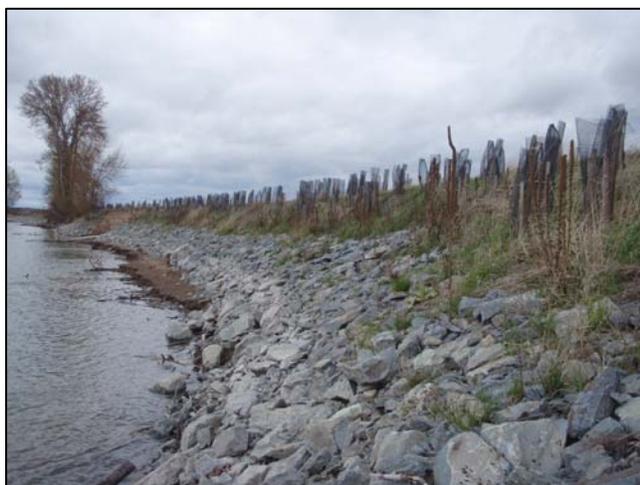
**Figure 18.** Rip-rap on banks along Flathead Site

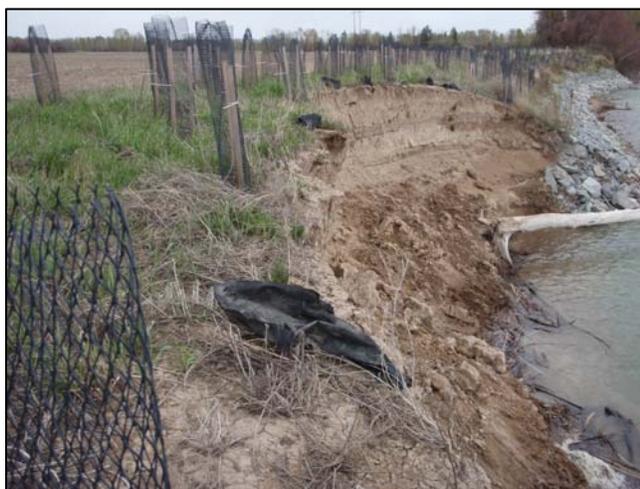
**Figure 19.** Blown-out section of bank

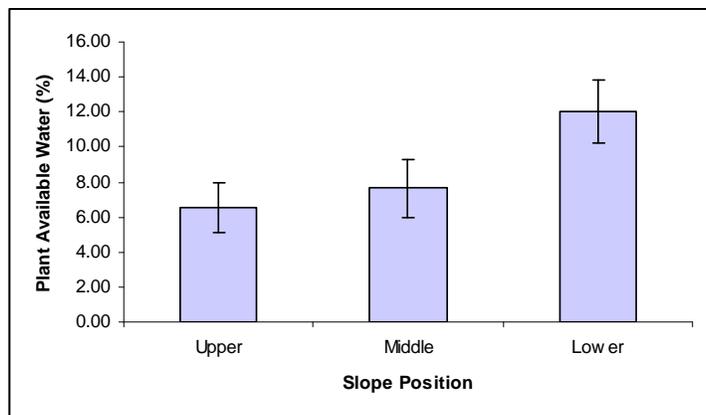
**Figure 21.** Percent plant available water by slope position at the Flathead River Re-vegetation Site.

We found that soil moisture varied greatly between slope positions but also between horizons within the same pit on this particular site. As would be expected, the pits nearest to the field had the least plant available water and the pits nearest to the river overall had the most plant available water (Figure 21).

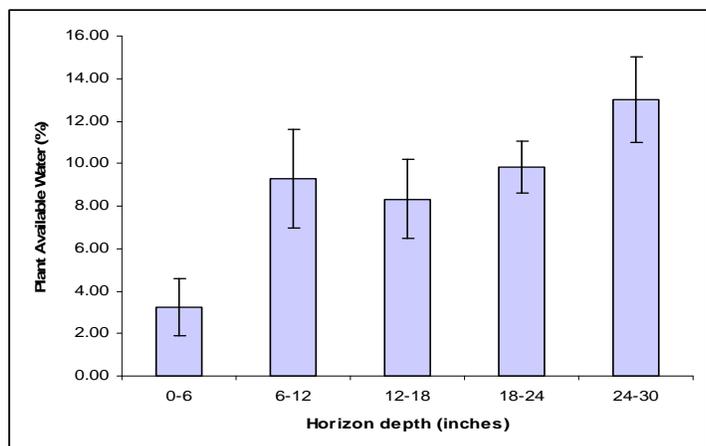
**Figure 22.** Percent plant available water by horizon depth at the Flathead River Re-vegetation Site.

We also found that the top soil horizon has minimal plant available water versus even the second soil horizon (6-12 inches). Moving lower in the profile, percent available water increases (Figure 22).

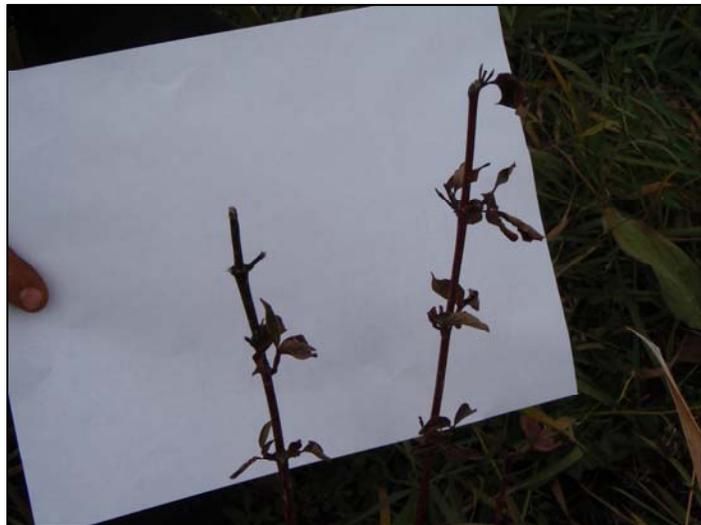
**Figure 23.** Browse after first year on Red osier dogwood

Plant vigor in the second year was low, due in part to plants being stunted from a first summer of heavy browse. Horsetail (*Equisetum arvense*) was seen growing out of the weed mats with our plantings in the lower and mid-slope positions. As Horsetail only grows in the presence of water, it is an interesting indicator of available soil moisture and demonstrates that lack of water is not the factor preventing plant establishment.

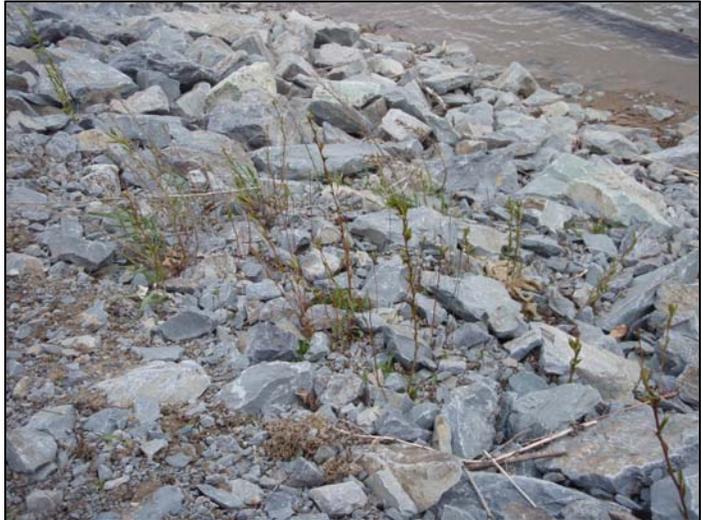
**Figure 24.** Cottonwood regeneration emerging through rip-rap.

Before the start of the revegetation portion of the project a large amount of rip-rap was piled into the water to prevent loss of streambank. This work was done by a large excavator that made multiple passes along the top of the bank and whose shovel likely patted the streambank soils down after re-grading. The compaction caused by this equipment dramatically affected plant growth (Figure 25). The ground was so compact during planting that picks were used instead of hods.

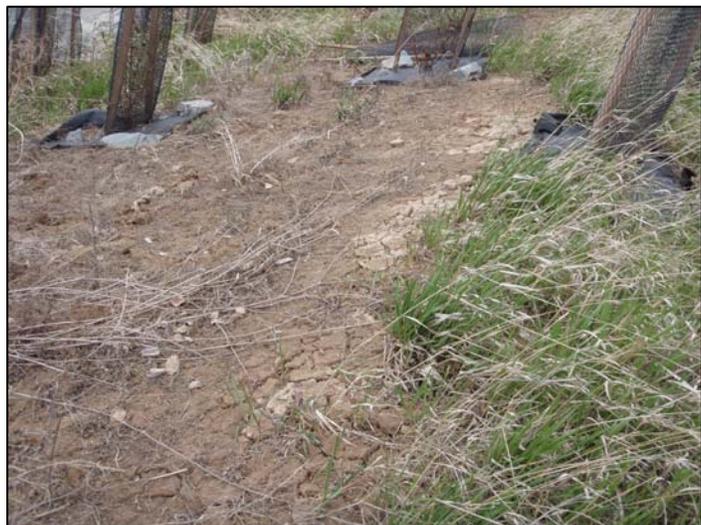
**Figure 25.** Some areas were devoid of plants, even weeds. Mechanical compaction is the likely cause.

Using a soil penetrometer we tested for soil compaction everywhere we came to a patch of dead plants. The correlation between plant mortality and compaction was 1 to 1. Where compaction was most severe, the upper soil horizons became platy, shown in Figure 26.

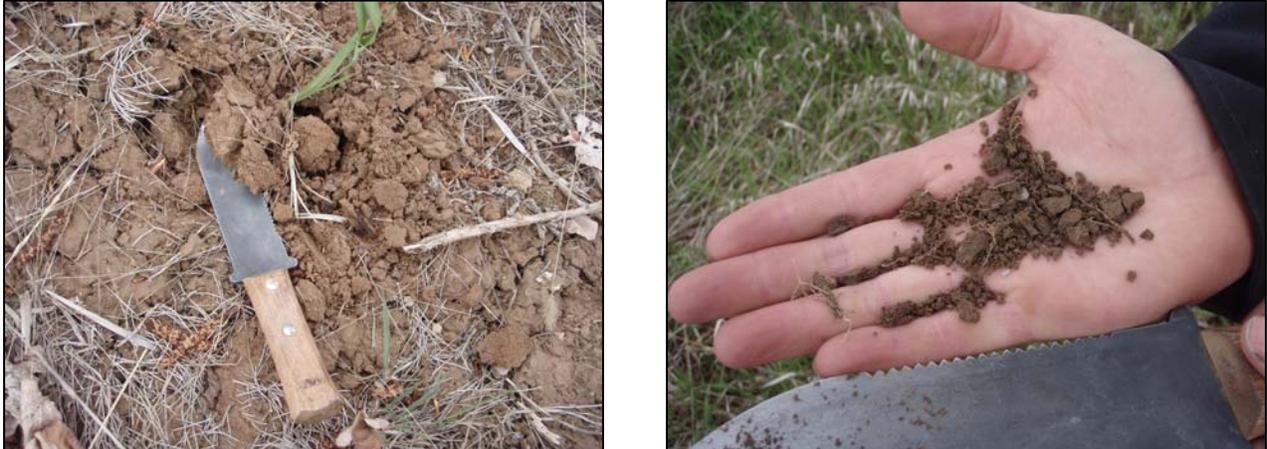
**Figure 26.** Platy soils in upper planting area.

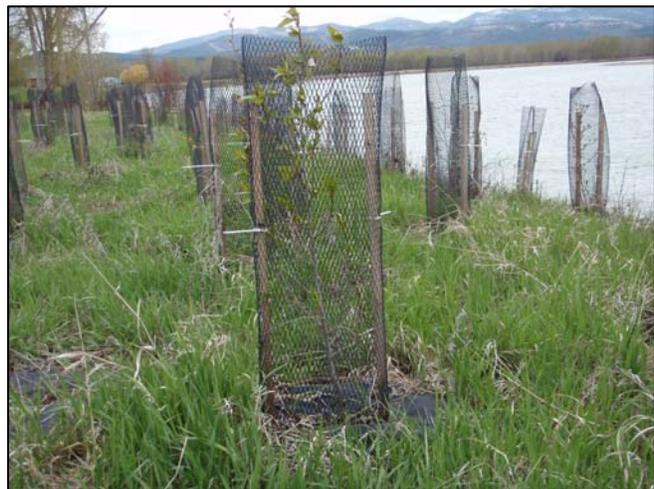
**Figure 27.** Plant growth in southernmost section beginning to poke through netting

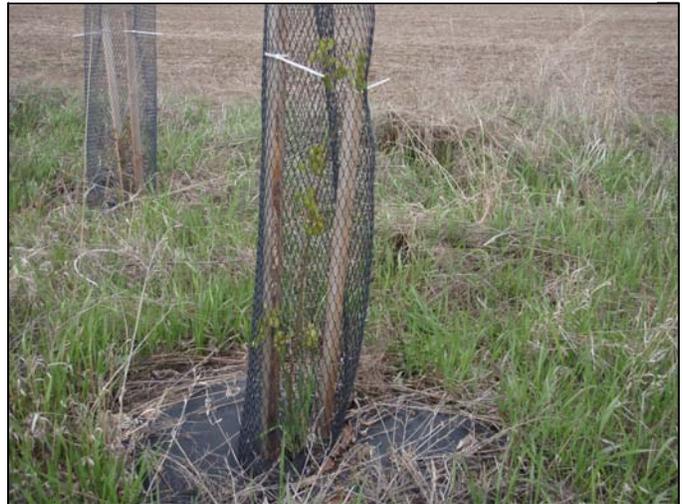
**Figure 28.** Weed mat suppressing brome grass around plant, but it comes up through planting hole

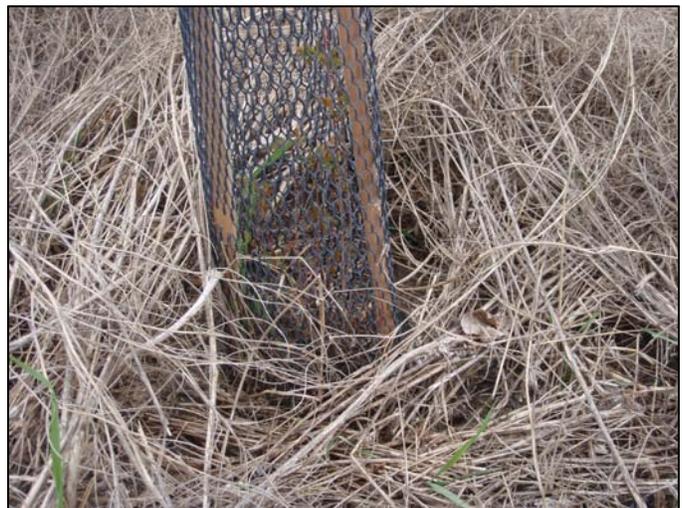
**Figure 29.** Aggressive weed in mustard family taking over a planting

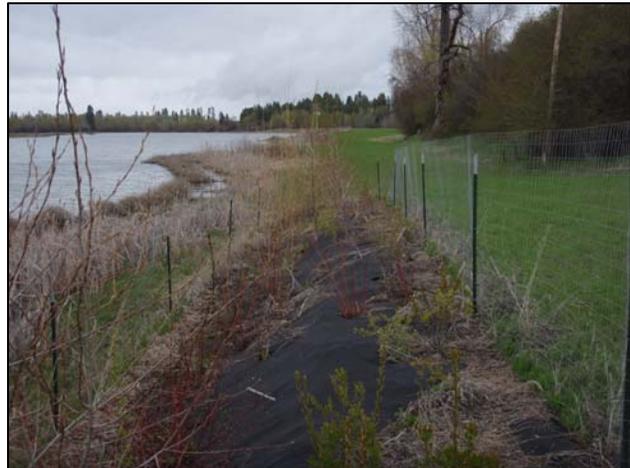
**Figure 30.** Vigorous growth in Egans Slough plantings

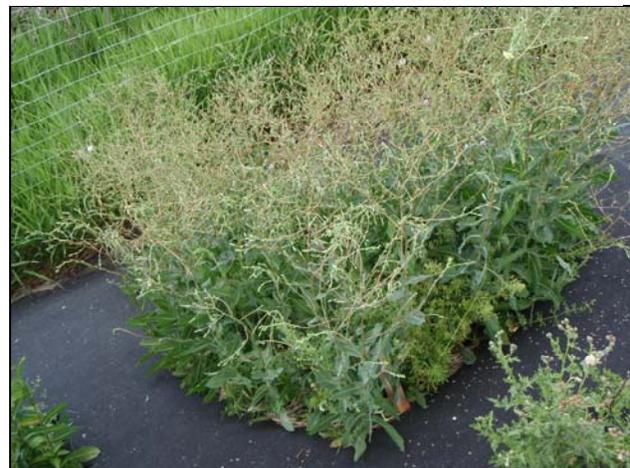
**Figure 31.** Weeds completely taking over opening in weed mat (Fall, 2008)

In areas where we exposed the soil under the mat, weeds completely dominated native vegetation (See Figures 31). Most of the exposed areas contained a thick (5 + cm) layer of matted reed canary grass and thistles, and occasionally hounds tongue and mullein. By the end of July 2008, the majority of the openings were completely weed covered. Once established in these openings, the weeds found openings in planting holes. Ninety percent of the native plants grew enough to survive the weed infestation, but there was some mortality.

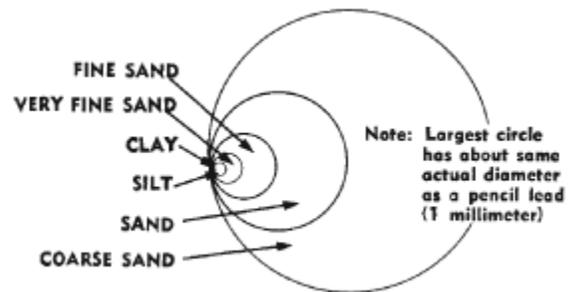
Comparison of clay, silt and sand particles

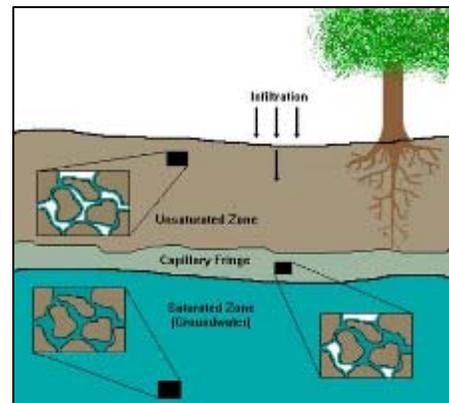
**Figure 32.** Capillary fringe diagram

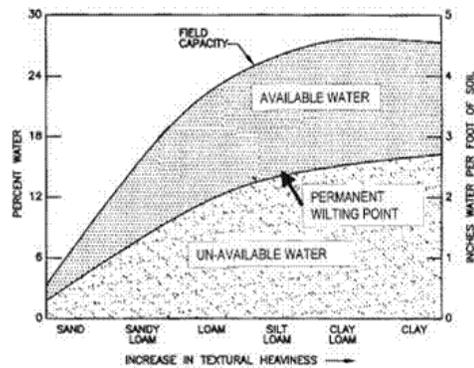
**Figure 33.** Soil water volume versus soil texture.

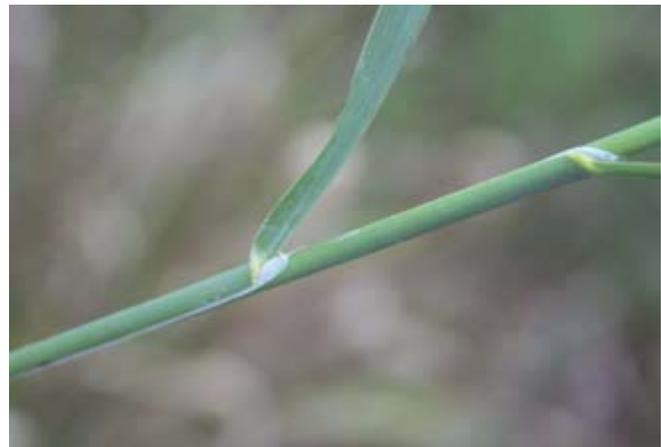
**RCG can be identified by rounded stem with prominent ligule or papery membrane at the base of its leaves (Wisconsin, 2009).**
